## Report XXXXXXXX

Site address: XXXXXXXX XXXXXXXX XXX XXX

### LEAK/ROOF INVESTIGATION

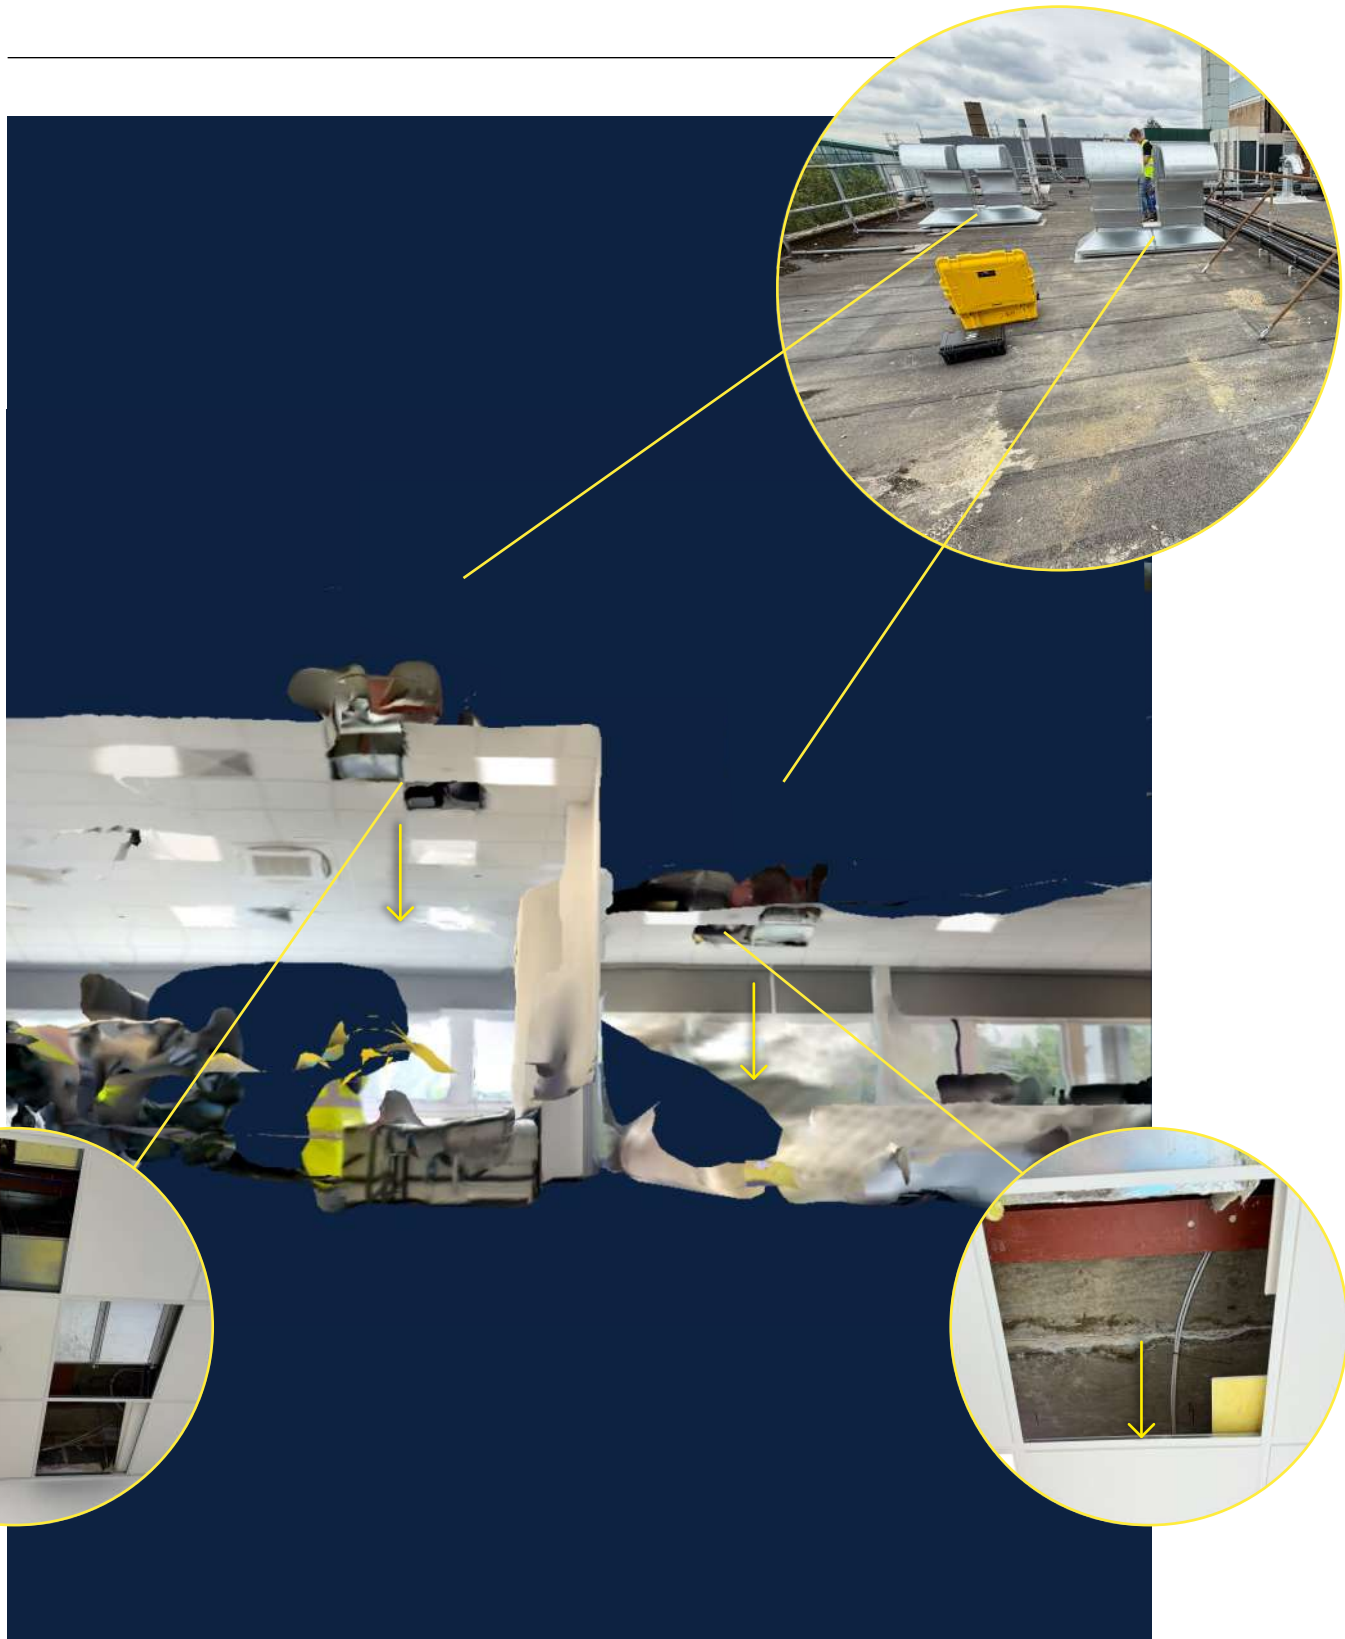
A 3d scan was used to identify the locations of the two reported leaks. The bottom right image in the yellow circle shows a crack in the structural slab with limescale deposits on either side. This indicates an ingress that has been going on for a prolonged period, potentially years. I was informed that the ducting on the roof was recently installed.

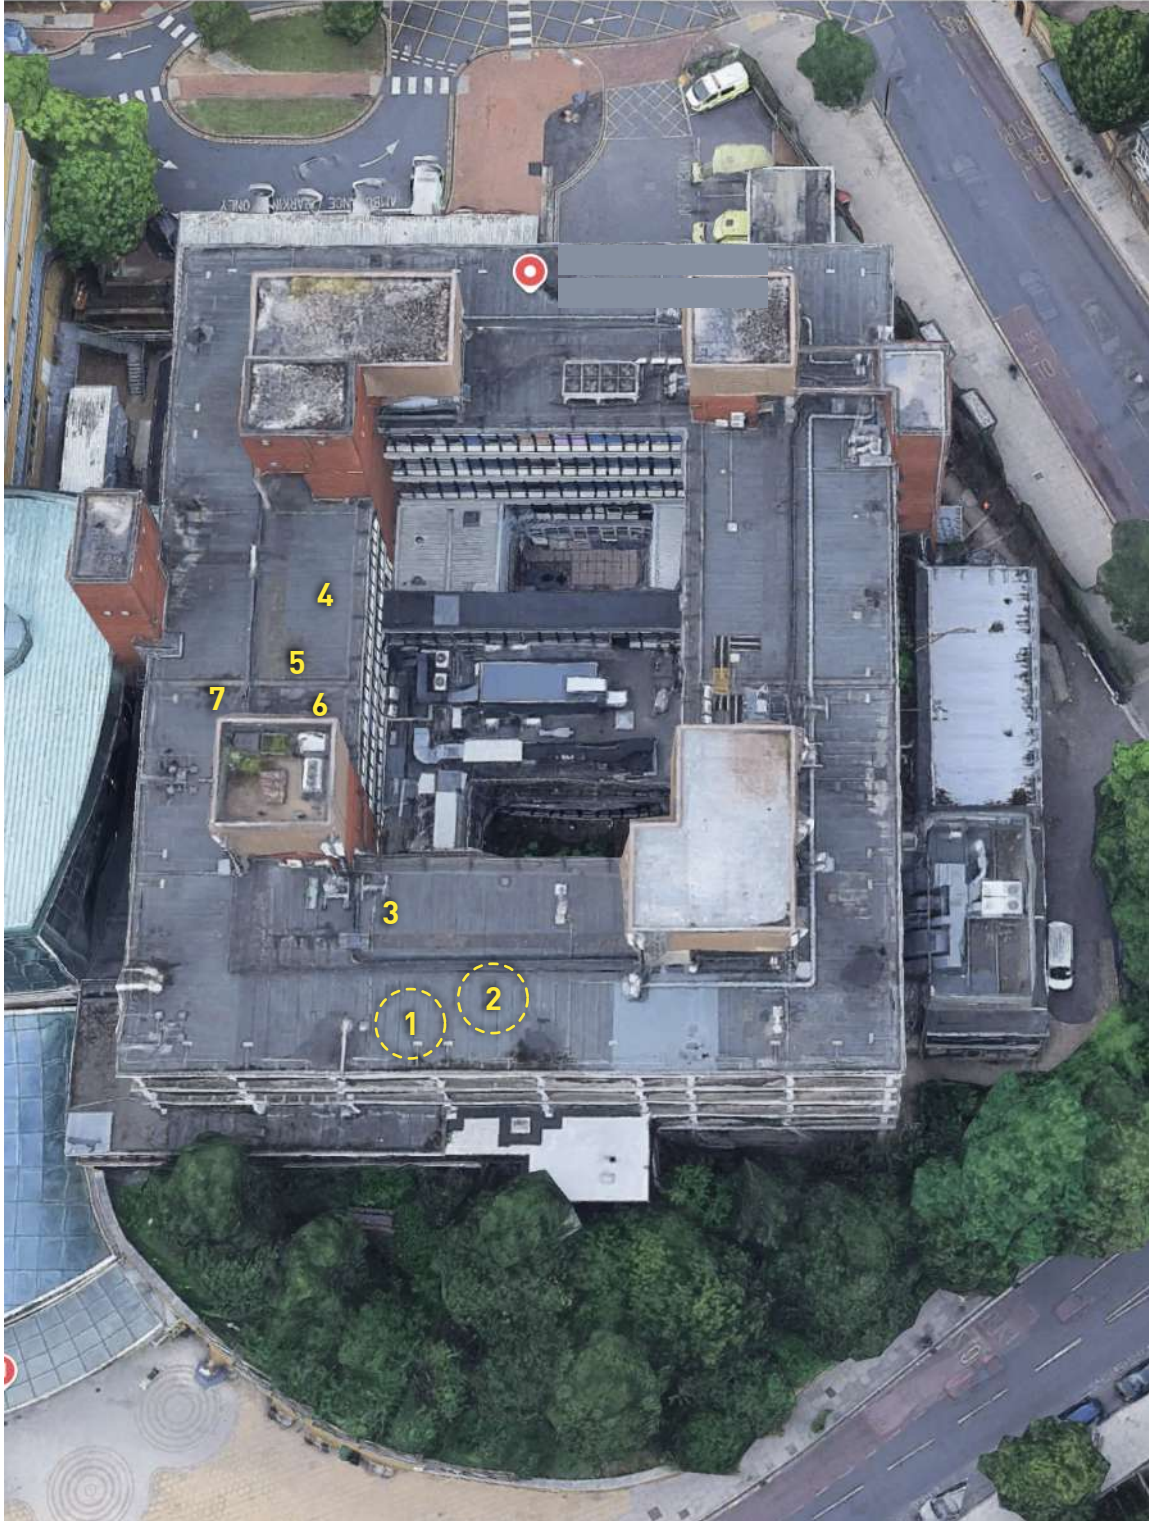
7 ducts installed. Locations shown on the Google Earth image above.  
The dotted yellow circles show the two locations of water ingress.

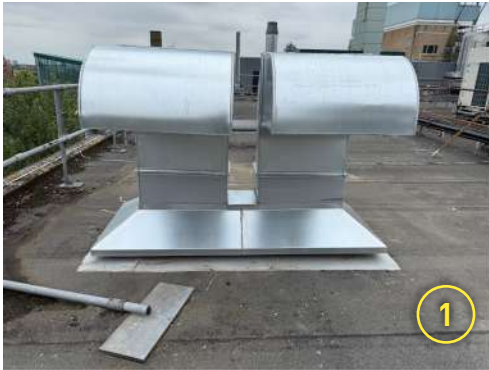
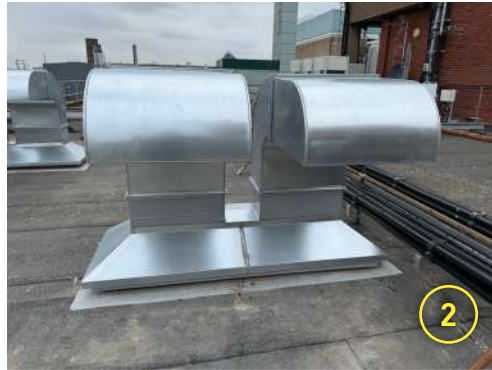
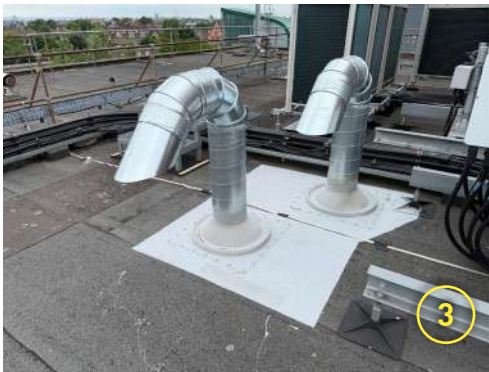
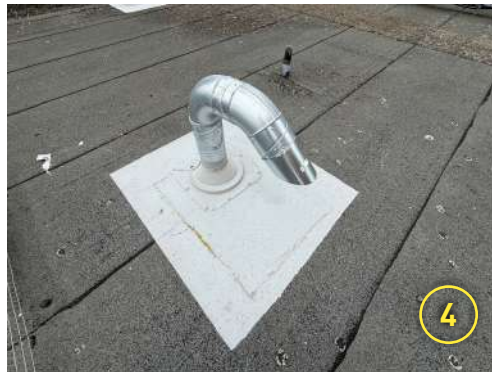
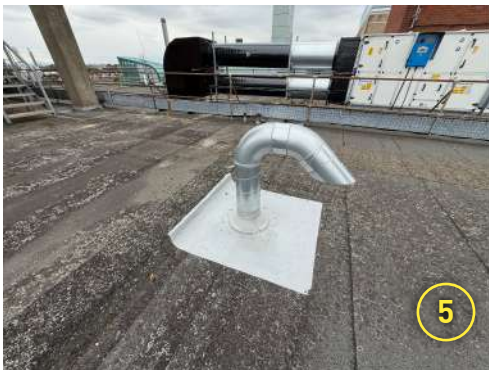
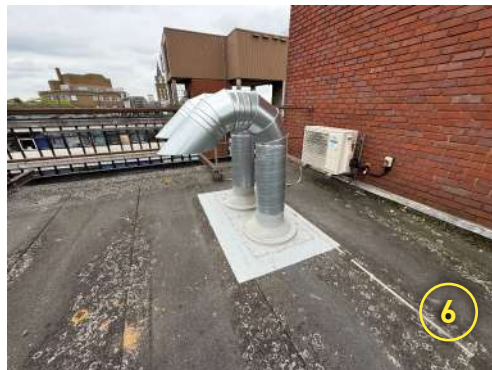
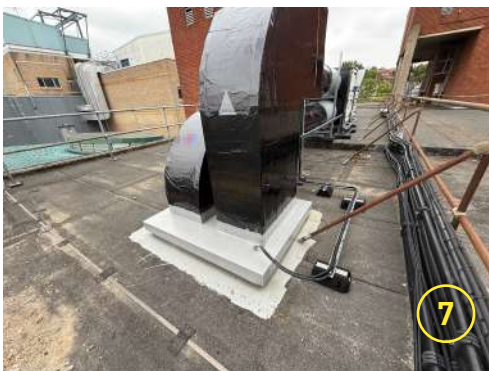
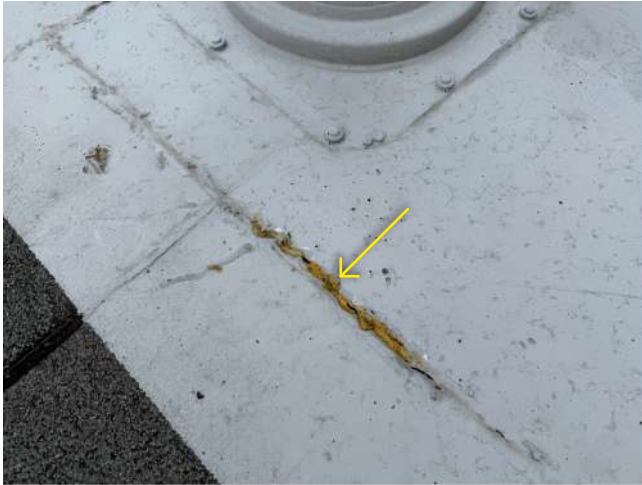
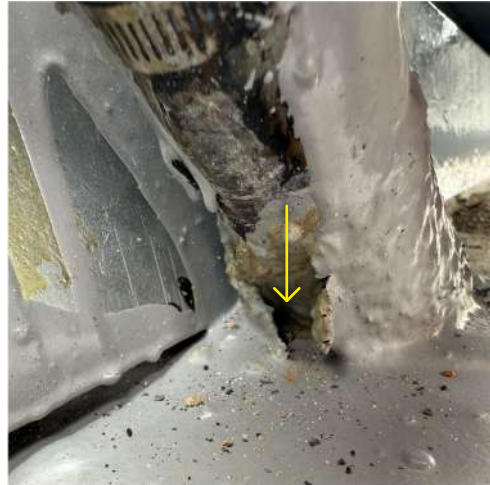
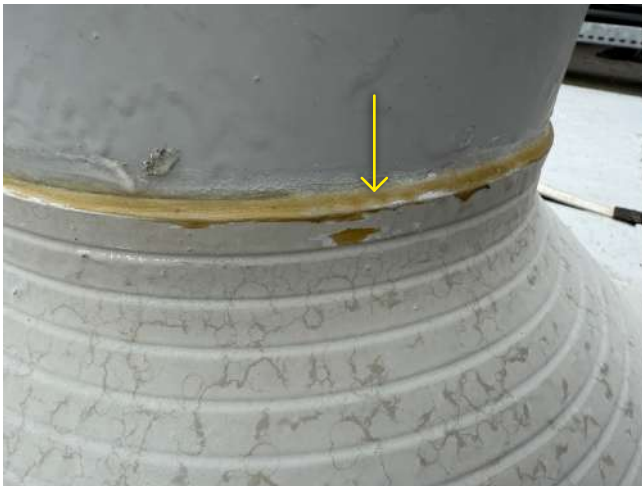
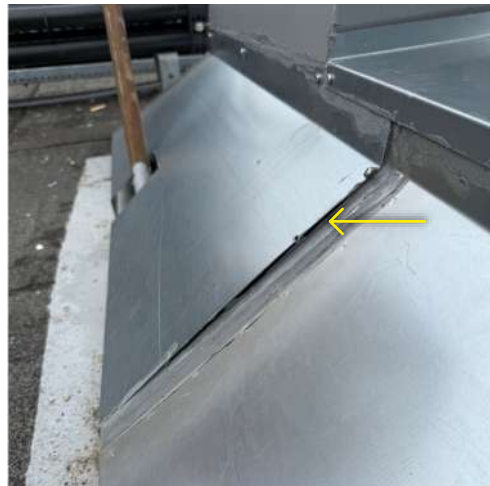
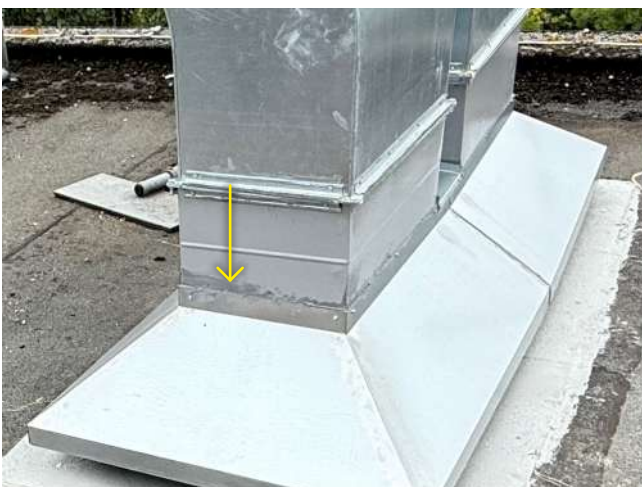
**SEVERAL ISSUES RELATING TO THE DUCTING WERE IDENTIFIED:**

- Silicone has been used to seal bitumen joints. The two products are not compatible, they will react with each other and break down.
- We always recommend using reinforcement matting with liquid water roofing products, whether it be fabric or fibreglass. Without this, liquid products only tend to last a year or two without splitting. With reinforcement, 15-25 years can be expected.
- The sealed joints of the ducting could be improved. Daylight can be seen when looking inside the ducts, and water ingress will be possible in these areas.

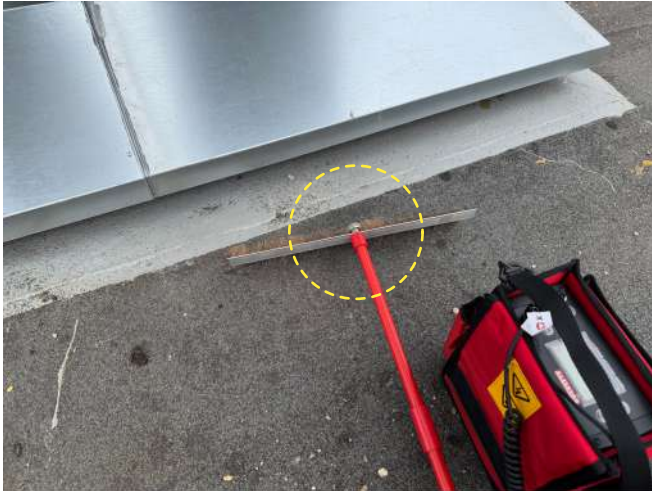
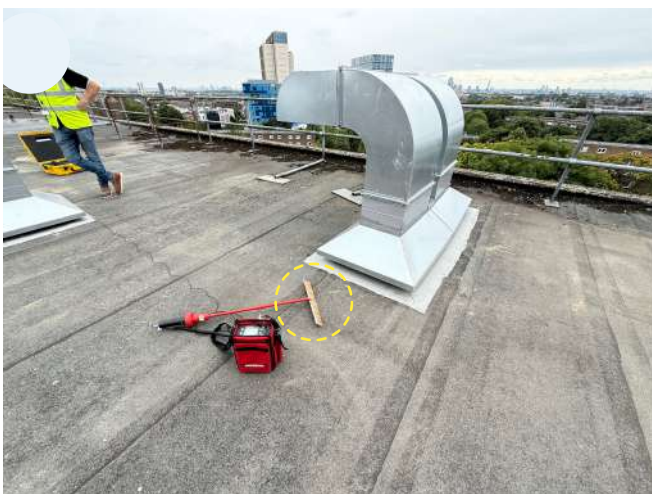
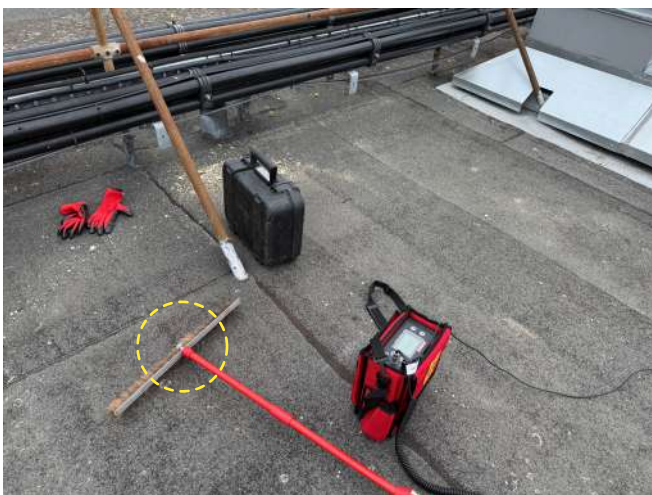
Electronic dry roof testing was carried out in the area around ducts 1 and 2. Several areas of torch-on felt waterproofing were found to be failing. Water ingress will be possible at each of the areas highlighted in the images above. The area tested is only 6m<sup>2</sup> of a much larger roof.

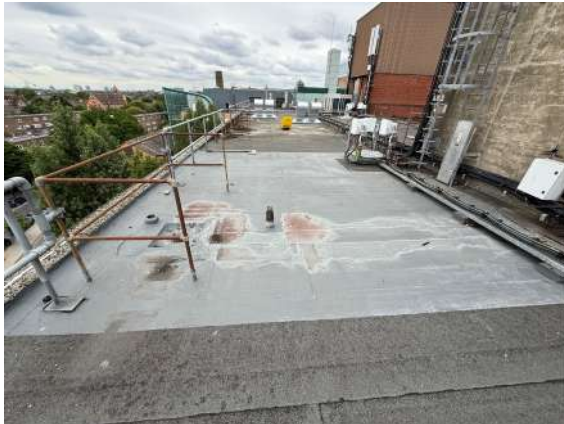
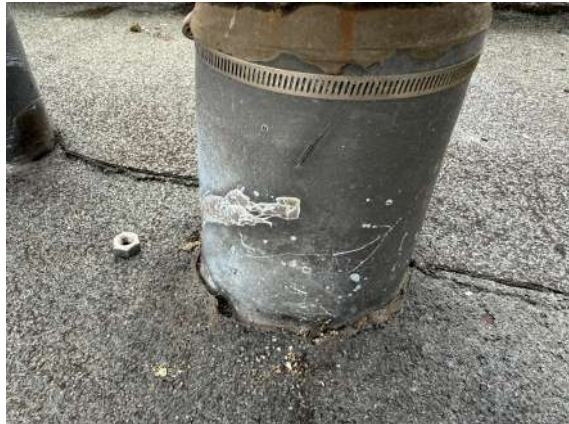
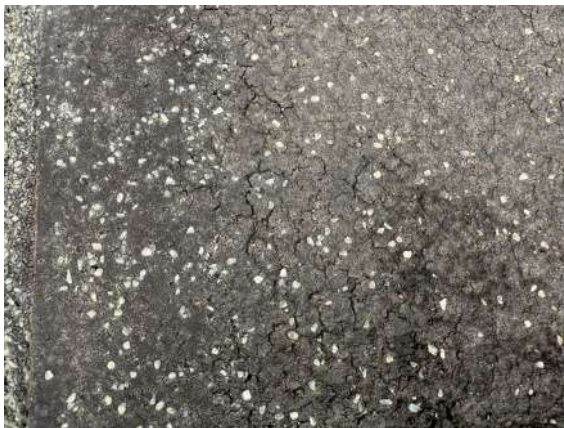
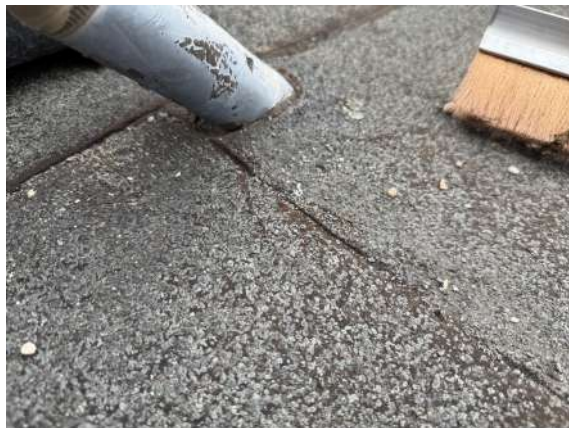
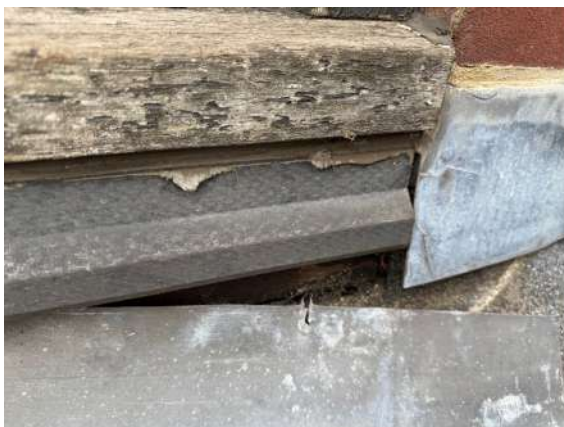
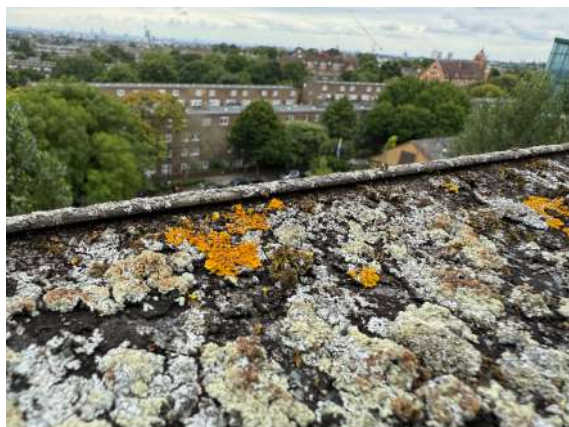
**NUMEROUS WATERPROOFING ISSUES WERE IDENTIFIED:**

- Protrusions through the waterproofing should be sealed from the roof surface to approximately 6 inches high.
- Liquid waterproofing repairs have split due to no reinforcement matting.
- The waterproofing capping sheet has become worn and split due to old age. The waterproofing is at the end of its life and it is strongly recommended that recovering is carried out soon to prevent ongoing and further leaks.
- Flashings have come loose, exposing the open top edge of the waterproofing.
- Perimeter trims to be sealed.

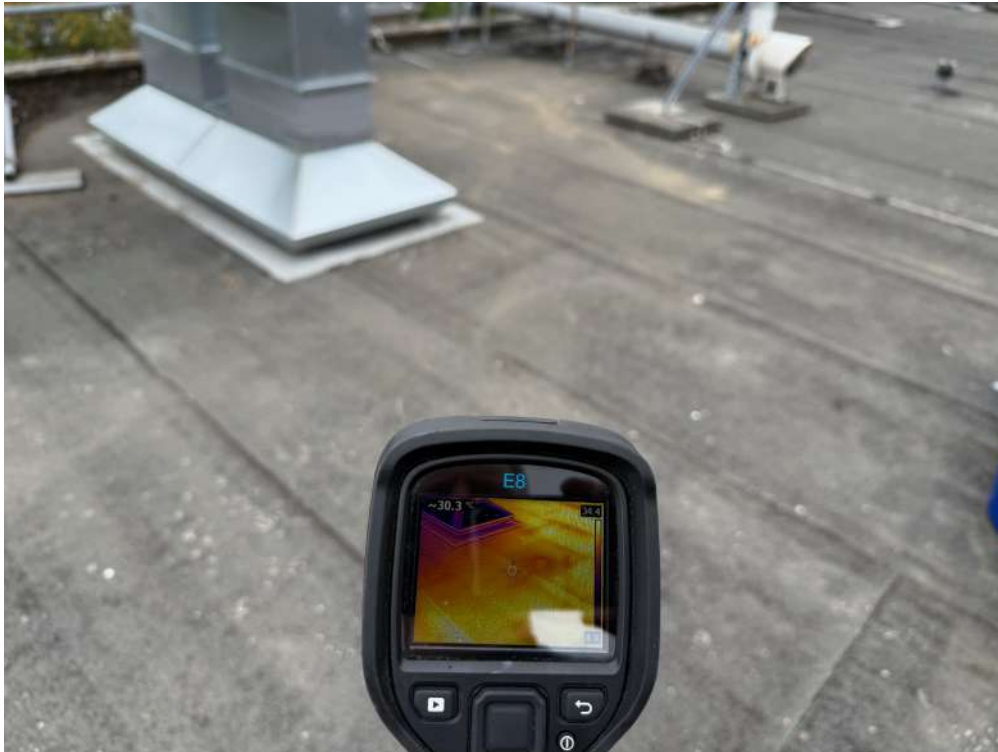
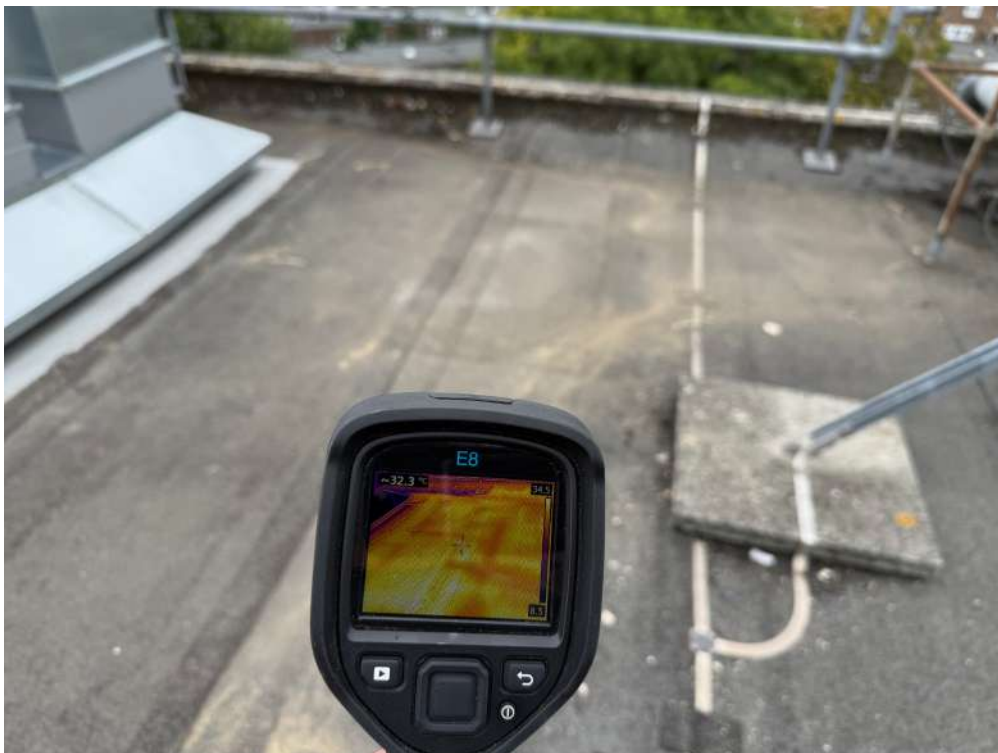
The FLIR images above indicate water under the waterproofing. During rainfall, water will travel under the waterproofing and insulation, spreading across the slab. Cracks and voids in the slab will create routes for rainwater to enter the property.

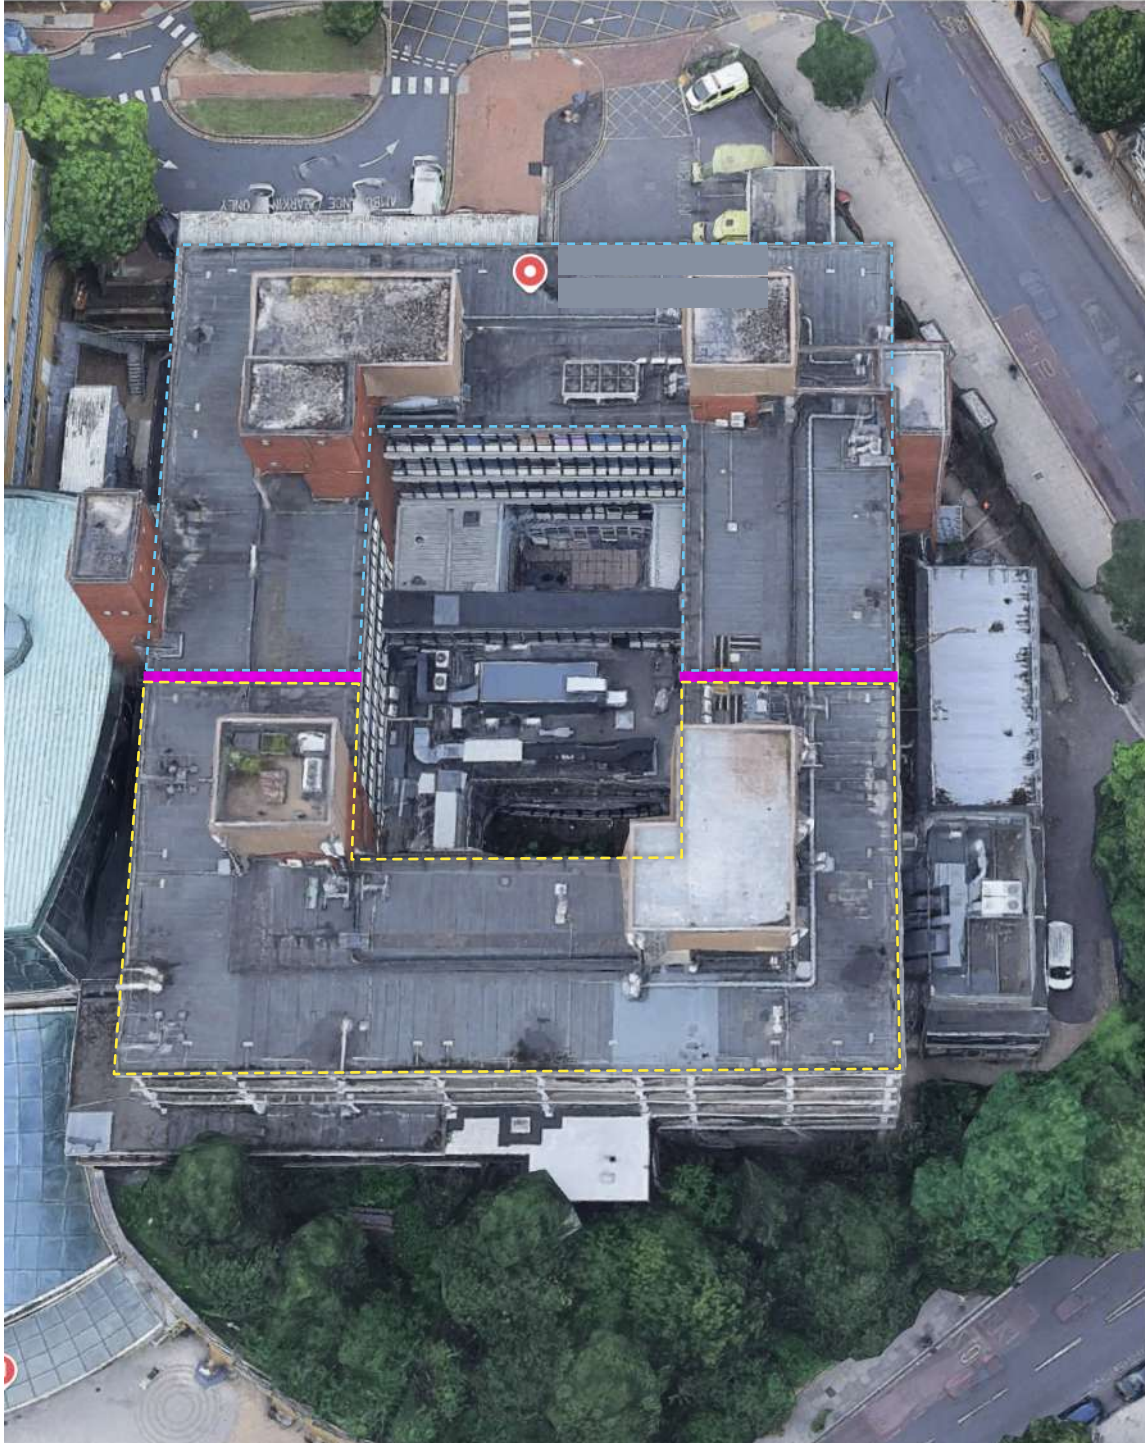
ROOF AREA WITHIN THE DOTTED YELLOW LINE = 1,250 M<sup>2</sup> / ROOF AREA WITHIN THE DOTTED BLUE LINE = 1,400 M<sup>2</sup>.

The roof is divided into two halves by small parapet walls as indicated with pink lines.

Ideally, the whole roof would be re-waterproofed, but the cost may be prohibitive. The area within the yellow dotted lines should be carried out before the existing waterproofing degrades further. A quality liquid waterproofing system with reinforcement will work well and will be guaranteed up to 25 years. If the existing waterproofing degrades further, it may have to be removed and replaced. This will dramatically increase costs.
